TIP 233: Field Evaluation of the Service Life of Foul-Release Coatings in Columbia River

Mark Sytsma and Steve Wells
Portland State University

December 7, 2016

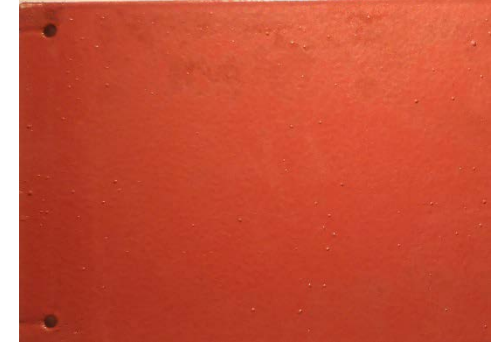
- Blistering.... Fuji (concrete) and Hemp (steel)

No 6 Few

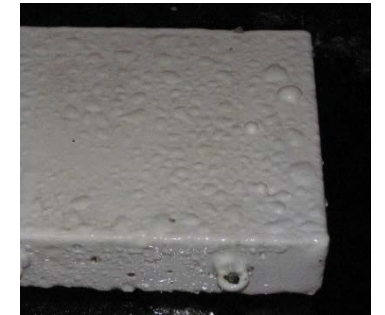
No 2 Medium Dense
